Tennies Home Inspection

Sample Report (pages 1-7 of 176)

Property Inspection Report

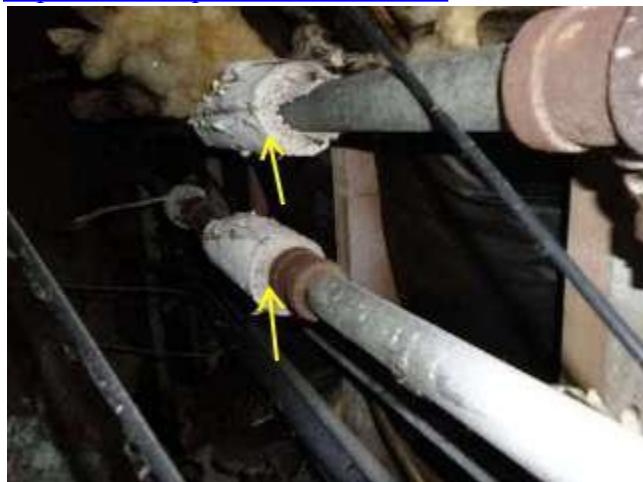
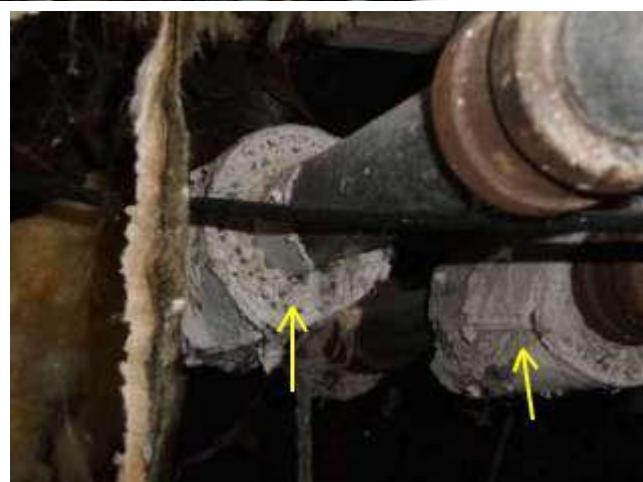
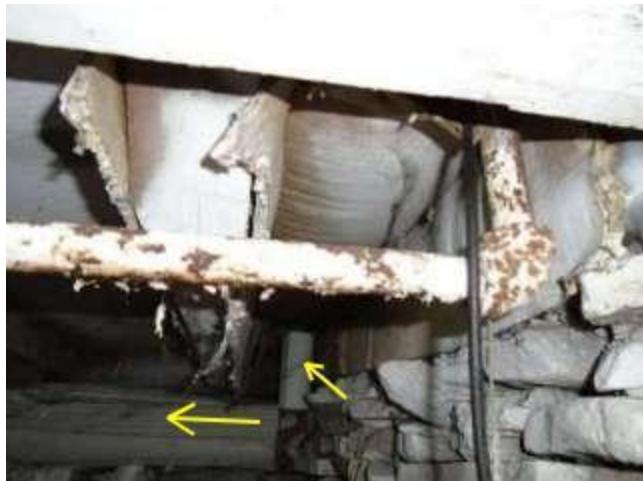
Structures built prior to the mid 1980s may contain lead and/or asbestos. Lead is commonly found in paint and in some plumbing components. The EPA does not recognize newer coats of paint as encapsulating older coats of lead-based paint. Asbestos is commonly found in various building materials such as insulation, siding, and/or floor and ceiling tiles. Laws were passed in 1978 to prohibit usage of lead and asbestos, but stocks of materials containing these substances remained in use for a number of years thereafter. Both lead and asbestos are known health hazards. Evaluating for the presence of lead and/or asbestos is beyond the scope of this inspection. Any mention of these materials in this report is made as a courtesy only, and meant to refer the client to a specialist. Consult with specialists as necessary, such as industrial hygienists, professional labs and/or abatement specialists for this type of evaluation. For information on lead, asbestos and other hazardous materials in homes, visit:

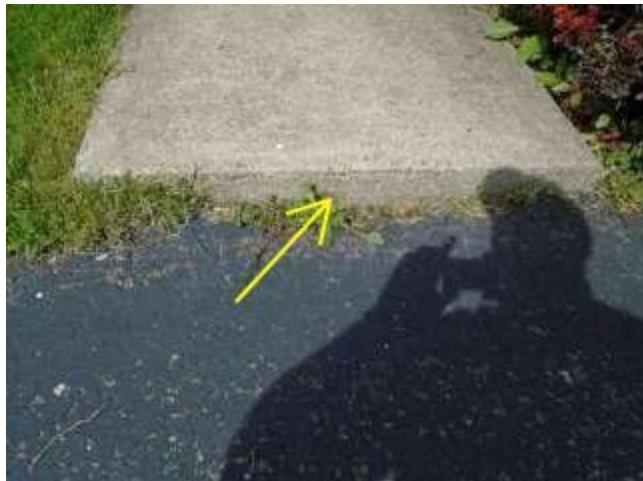
Photo 2-1

2) + Cracks, holes, settlement, heaving and/or deterioration resulting in trip hazards were found in the sidewalks or patios. For safety reasons, recommend that a qualified contractor repair as necessary to eliminate trip hazards.

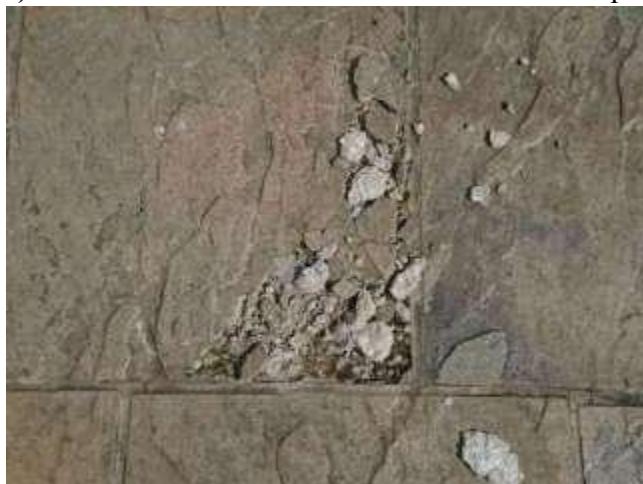
Photo 3-1

3) ↗ Tile deteriorated on deck. Recommend replacing with new tile and exterior grout.

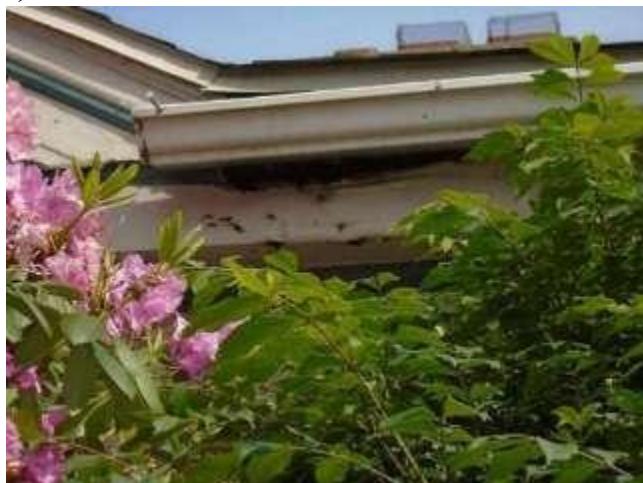
Photo 4-1

4) ↗ Soffit and fascia on South side is rotten and should be replaced by a qualified contractor.

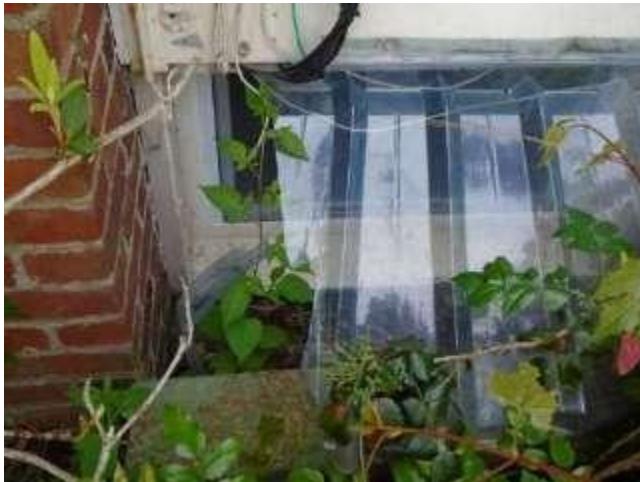
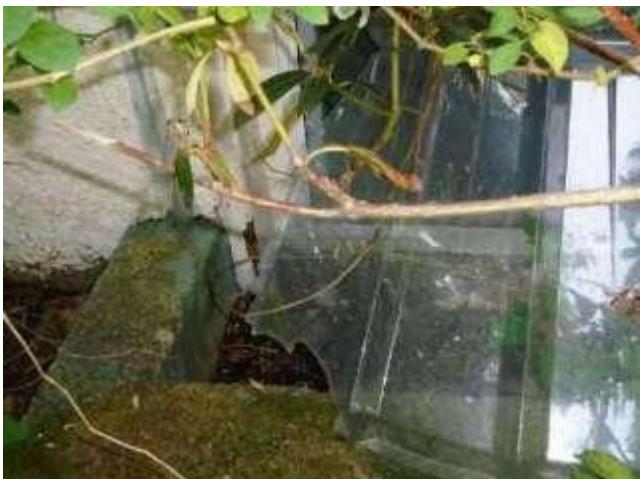
The plastic basement window covers are broken. Recommend replacing to keep out water and vermin.

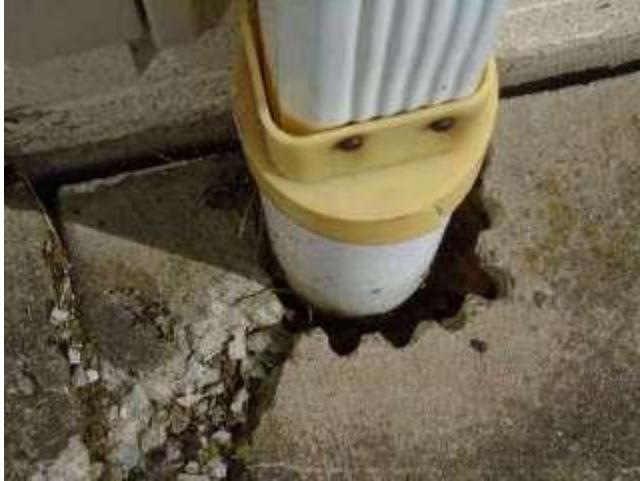
Photo 6-1

Pavement and or concrete repair to stop water intrusion.
